Manhole Inspection Summary

Manhole # S55A__012MH

Record Plat: **55A** Node: **012** Status: **Found**

Insp Date: **6/24/08 9:59 AM**

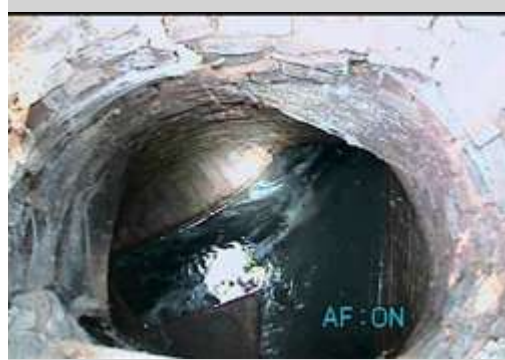
Top View

Comments **Has a crack that turns into a fracture going from Frame Adjustment all the way down to the channel.**

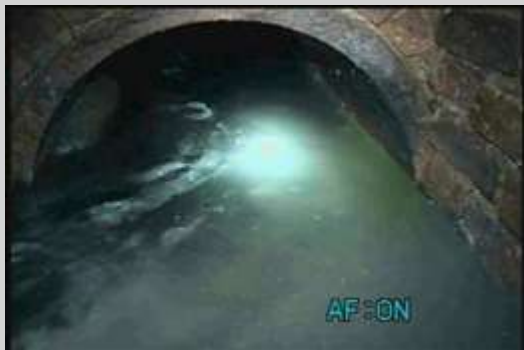
12 O'Clock Outflow

Invert Depth: **9.18** (ft.) Flow Characteristics: **Slow**
